**PHASE I RECONNAISSANCE  
SITE CHARACTERIZATION REPORT  
FOR THE  
SILVER CREEK DRAINAGE PROJECT**

**Lewis & Clark County, Montana**

**Olympus Technical Services, Inc.  
765 Colleen  
Helena, Montana 59601**

**February 2003**

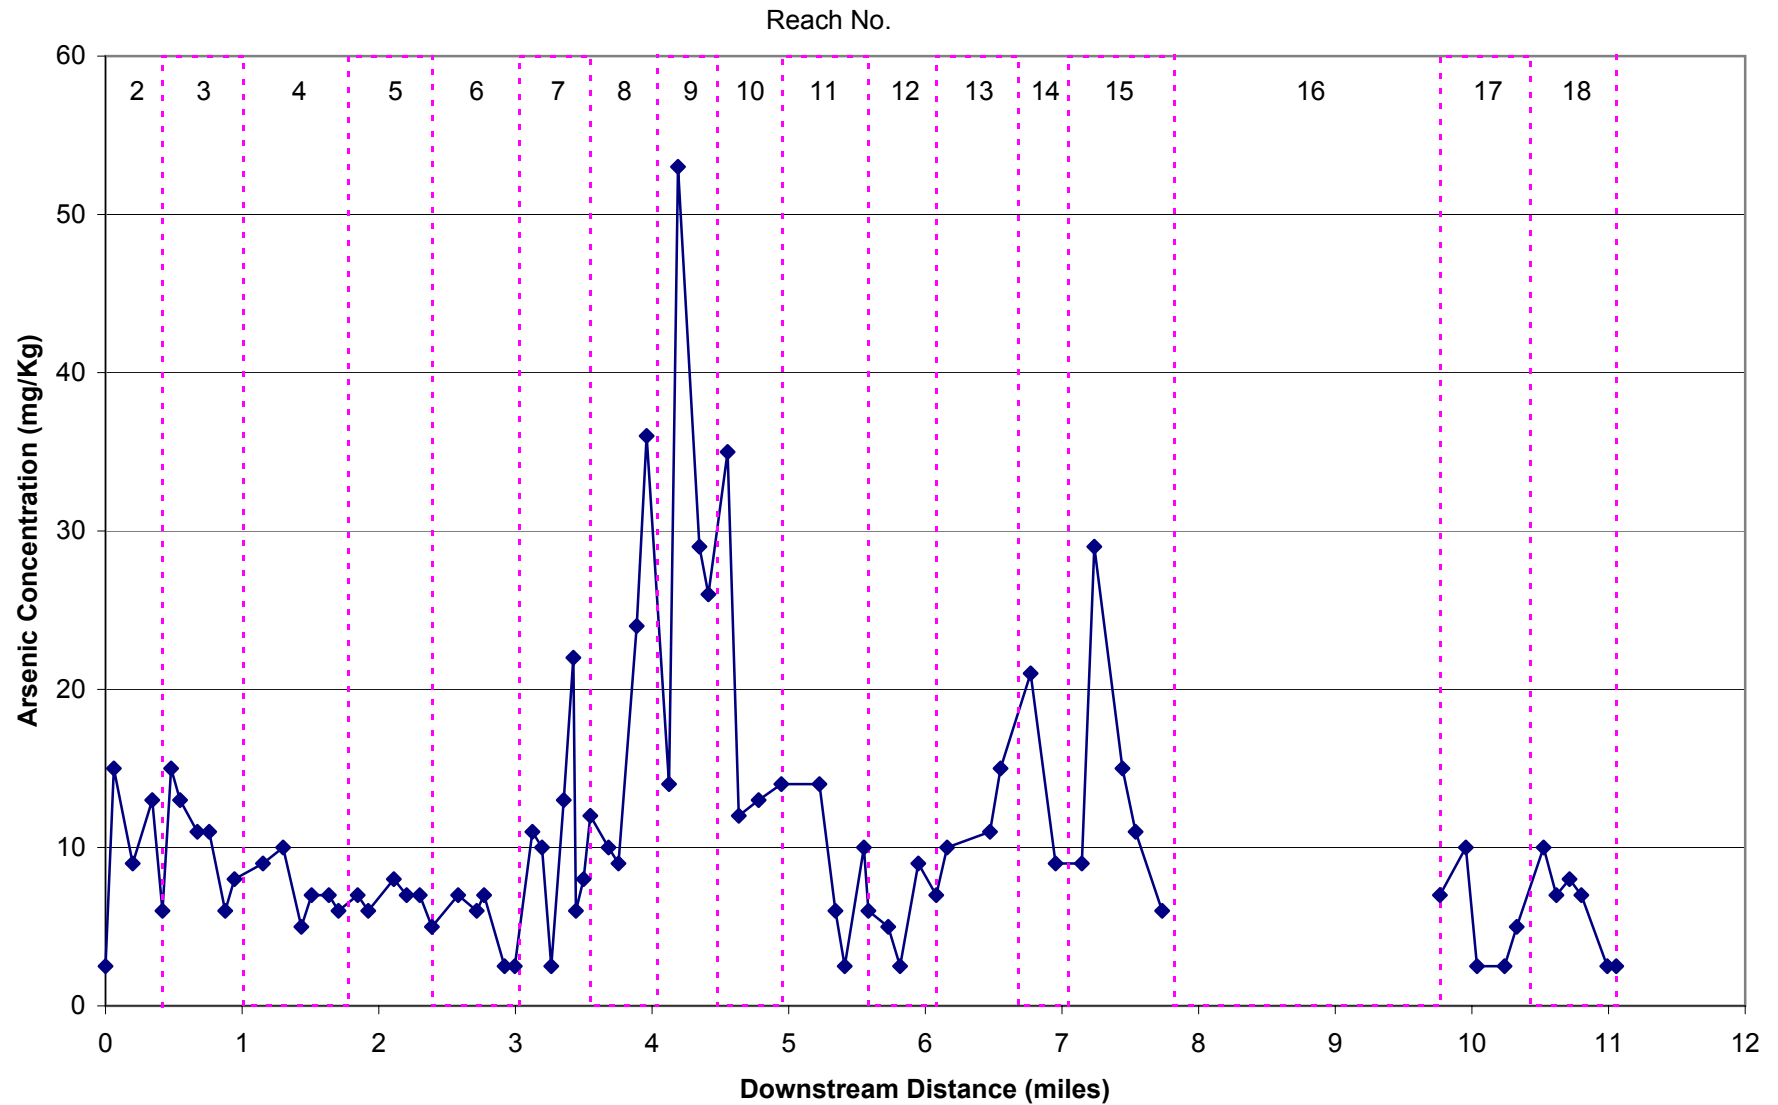
**Figure 6-3a. Arsenic in Silver Creek Stream Sediments**

Figures 6-3a through 6-3e show the concentration of arsenic, copper, mercury, lead and zinc along Silver Creek, and Figure 6-3f shows these concentrations along Jennies Fork. Figure 6-3a shows that peak arsenic concentrations occur in Reaches 8, 9, and 10, with smaller peak concentrations in Reaches 7, 14 and 15. Figure 6-3b shows that peak copper concentrations occur in Reaches 7 and 8, Reaches 14 and 15, and a smaller peak in Reach 18. Figure 6-3c shows that peak lead concentrations occur in Reach 7 and in Reaches 14 and 15. Figure 6-3d shows that peak mercury concentrations occur in Reaches 7 and 8, Reaches 13, 14 and 15, and a smaller peak in Reach 18. Figure 6-3e shows that peak zinc concentrations occur in Reaches 7 and 8, and in Reaches 14 and 15. Figure 6-3f shows that metal concentrations are relatively constant along Reach 1. Comparison of Figures 6-3a through 6-3e indicate consistent patterns among reaches, with peak concentrations consistently occurring in Reaches 7, 8, 14 and 15. Reaches 7 and 8 are adjacent to the Goldsil tailings and millsite. Reaches 14 and 15 are downstream from Birdseye Road.

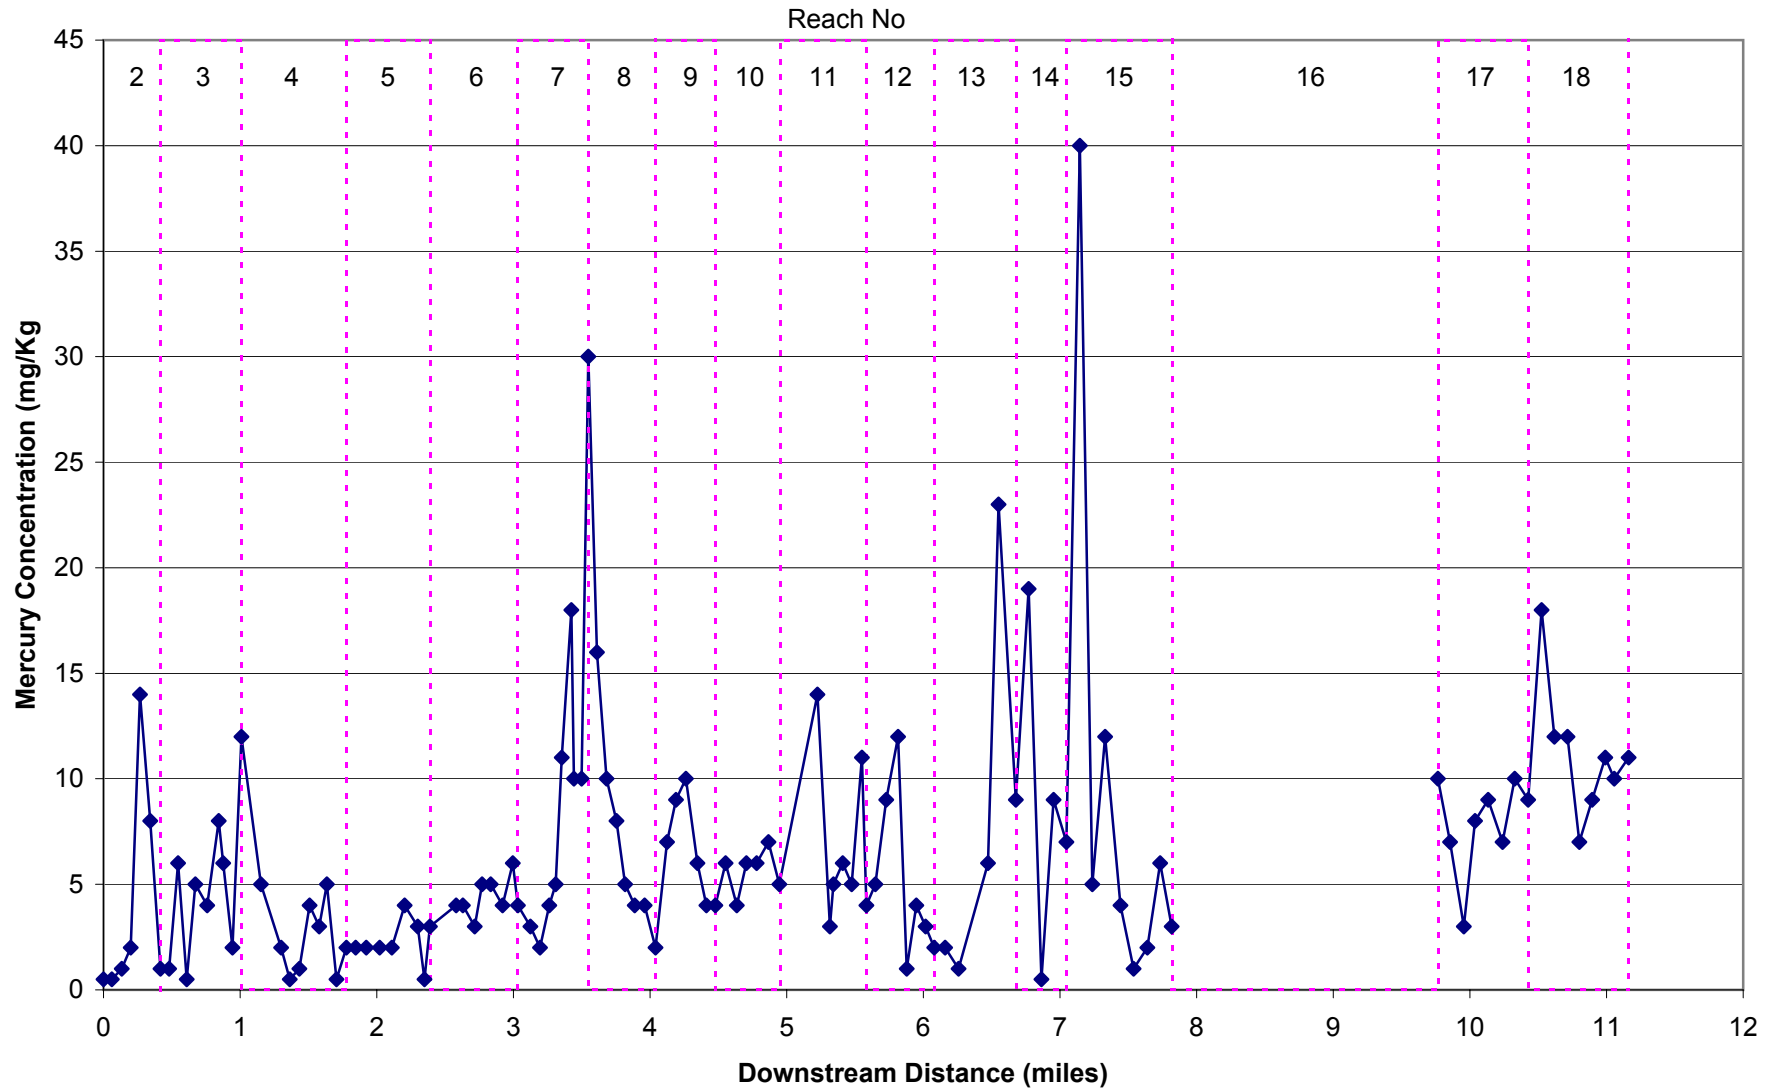
Figure 6-3d. Mercury in Silver Creek Sediments

The following are the laboratory median concentrations for each element analyzed in the stream sediments relative to the mean background concentration: As (0.4 times background or 0.4x), Cu (1.04x), Pb (3.2x), Hg (>8x) and Zn (1.02x). This comparison of stream sediment metal/metalloid concentrations to background indicates that mean arsenic concentrations are significantly less than background, while copper and zinc concentrations are approximately equal to background. Lead and mercury concentrations are elevated relative to background. It should be noted that the background soil concentration of mercury was taken as 0.5 mg/Kg (half of the detection limit) since mercury was not present above the detection limit in of 1 mg/Kg in the background samples. However, background soil samples collected by Pioneer had mercury concentrations ranging from less than 0.03 mg/Kg to 0.187 mg/Kg. Based on these data, the median mercury concentration could be greater than 100 times the times the mean background concentration.

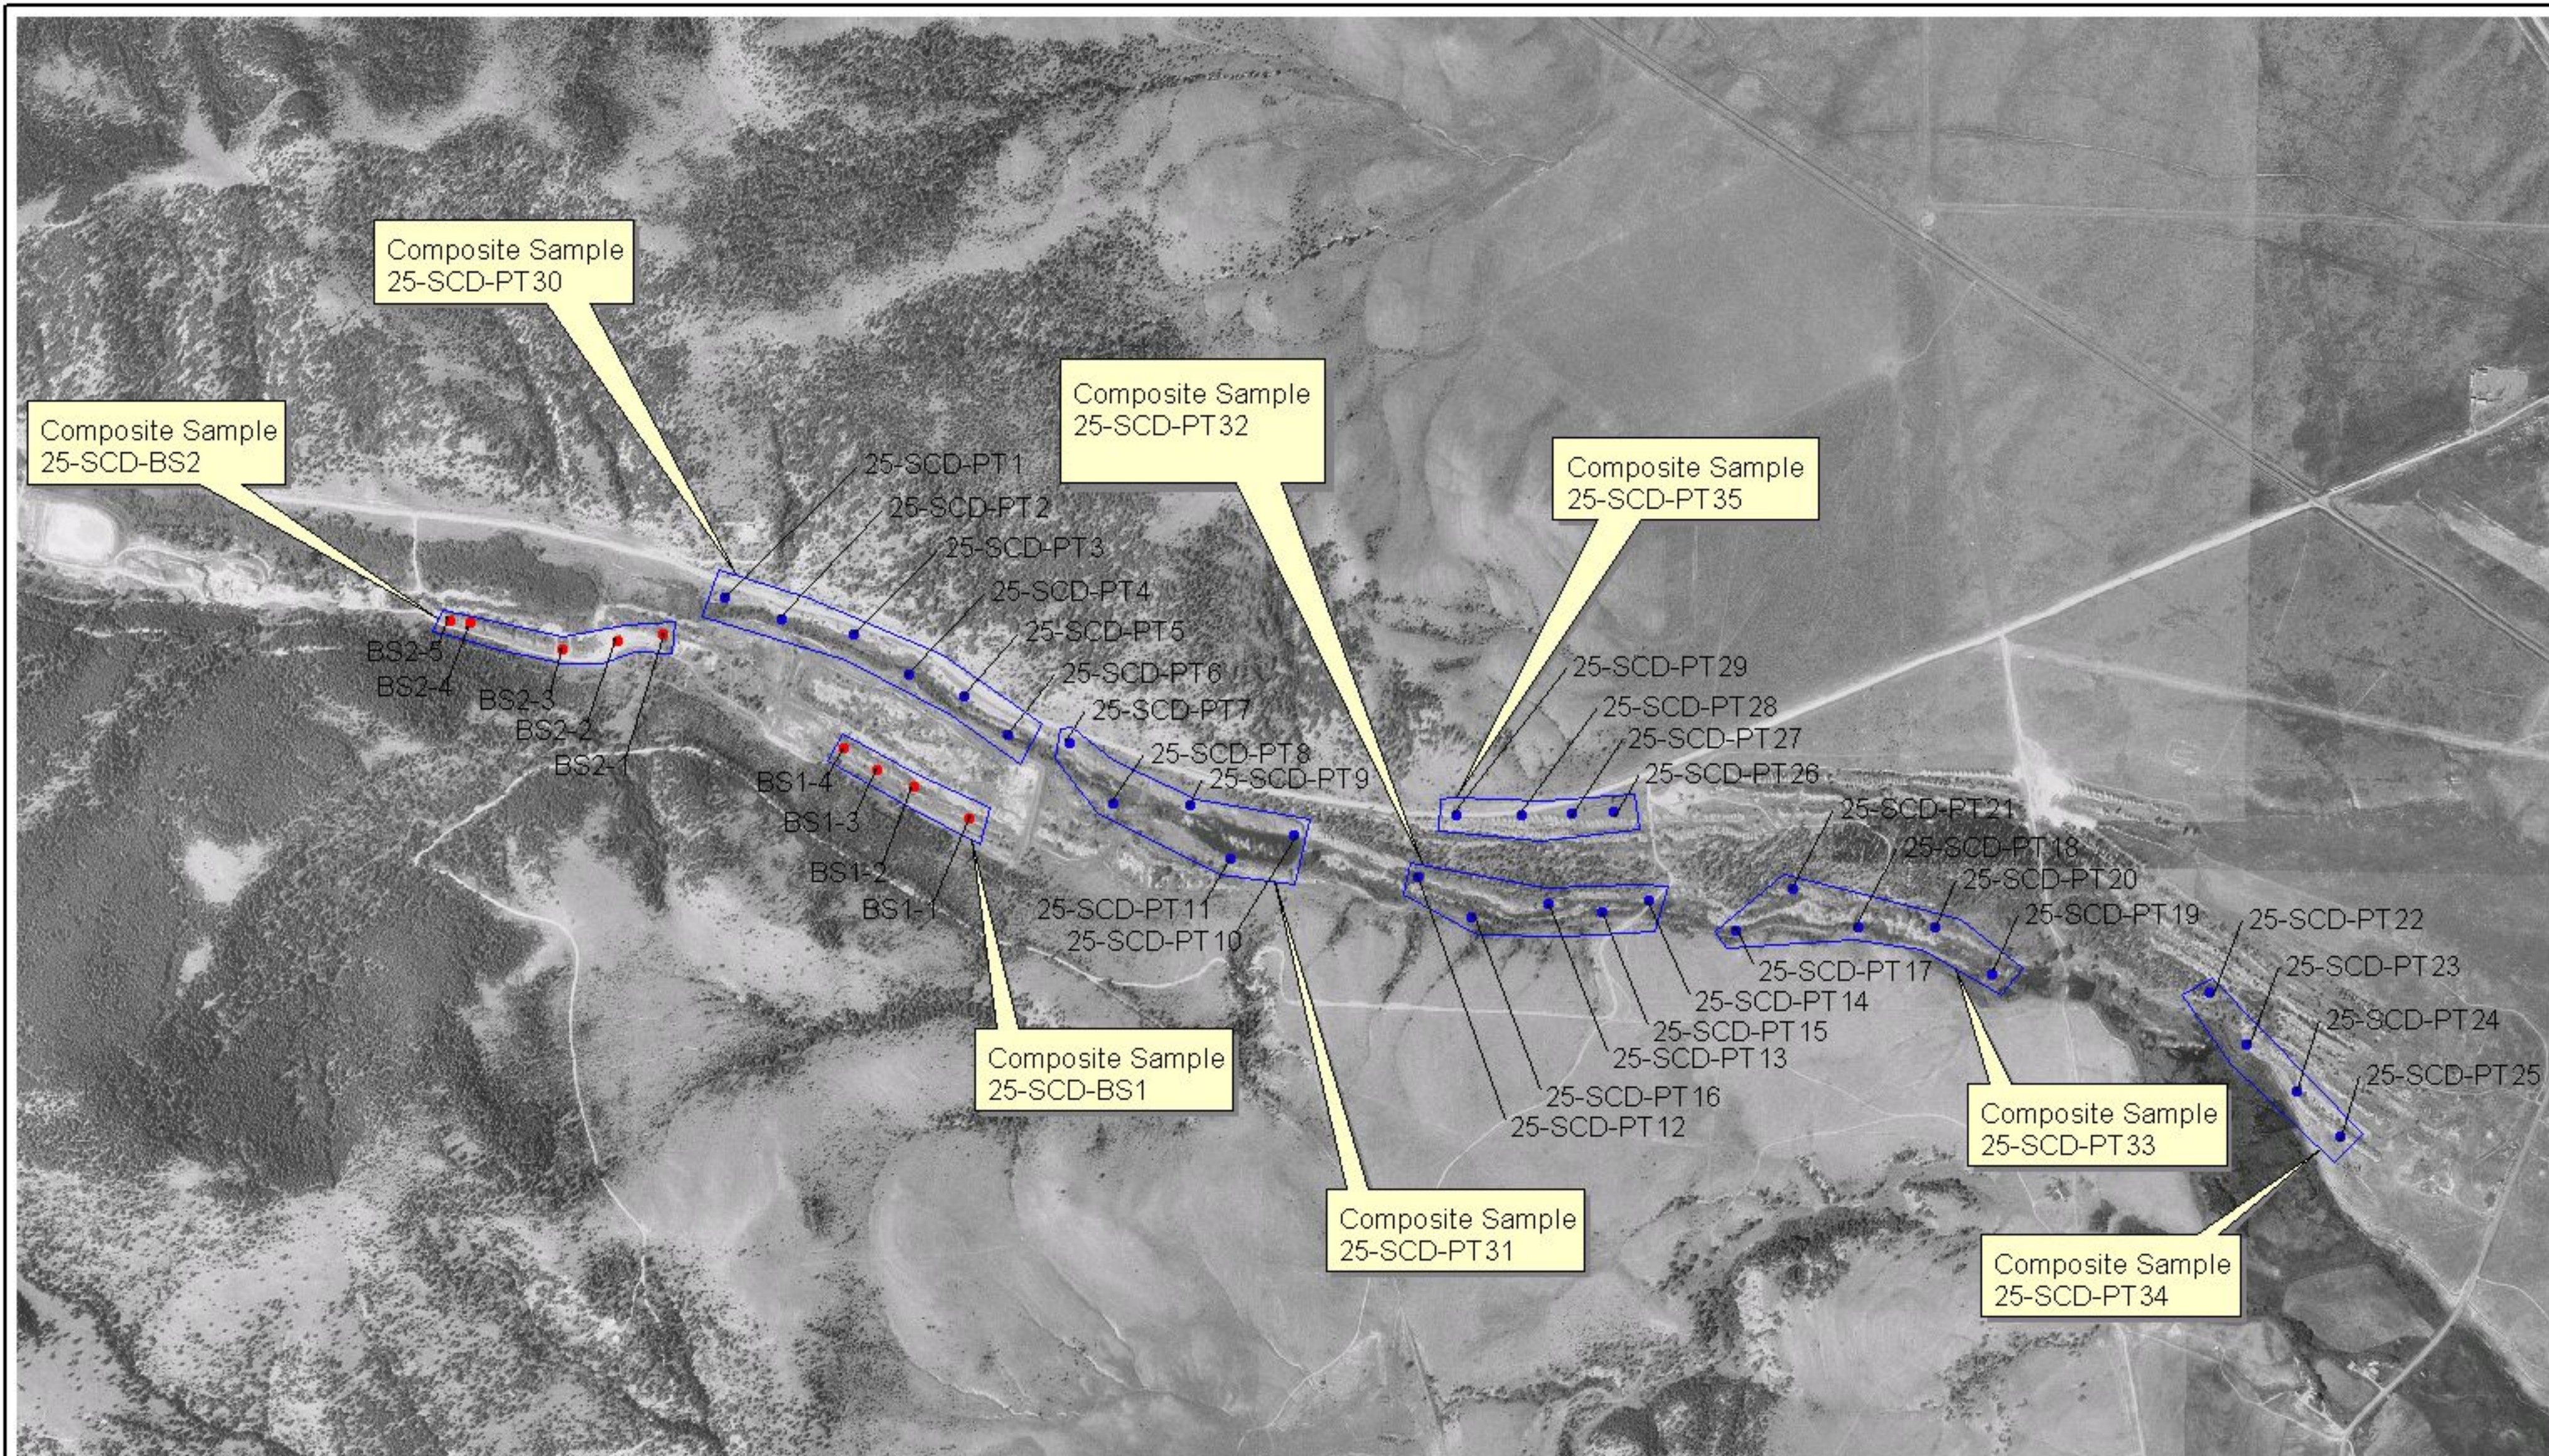
A total of 38 placer tailings samples were collected and screened for a multi-element suite using a portable XRF analyzer. The XRF analytical results are presented in Appendix C. The XRF analytical results were generally below detection limits, indicating that the metal concentrations are generally low. Eight composite samples were prepared for quantitative laboratory analysis. Five of the composite samples were from near-stream sources and were composited by stream reach to evaluate the chemistry of fine-grained placer tailings piles. The remaining placer pile samples were composited from a placer tailings pile located along Marysville Road (just west of the intersection with Little Falcon Road), from west of the Upper Pond and from south of the Lower Pond. The three composite samples from outside of the immediate stream corridor were also evaluated for borrow source suitability as presented in Section 6.3.2. The placer tailings sample locations are shown on Figure 6-6.

Of the eight composite samples collected, five contained mercury above the detection limit. Three of these samples were located out of the main stream corridor, and two were located within the stream corridor. The highest mercury concentration (7 mg/Kg) was observed in the placer tailings piles along Silver Creek in Reach 12. The second highest mercury concentration (4 mg/Kg) was observed in the placer tailings piles along Silver Creek in Reach 11. The remaining detectable mercury concentrations were observed in the placer tailings pile along Marysville Road (3 mg/Kg), in a placer tailings pile along the southern perimeter of the Lower Pond (3 mg/Kg) and in a placer tailings pile west of the Upper Pond (2 mg/Kg).

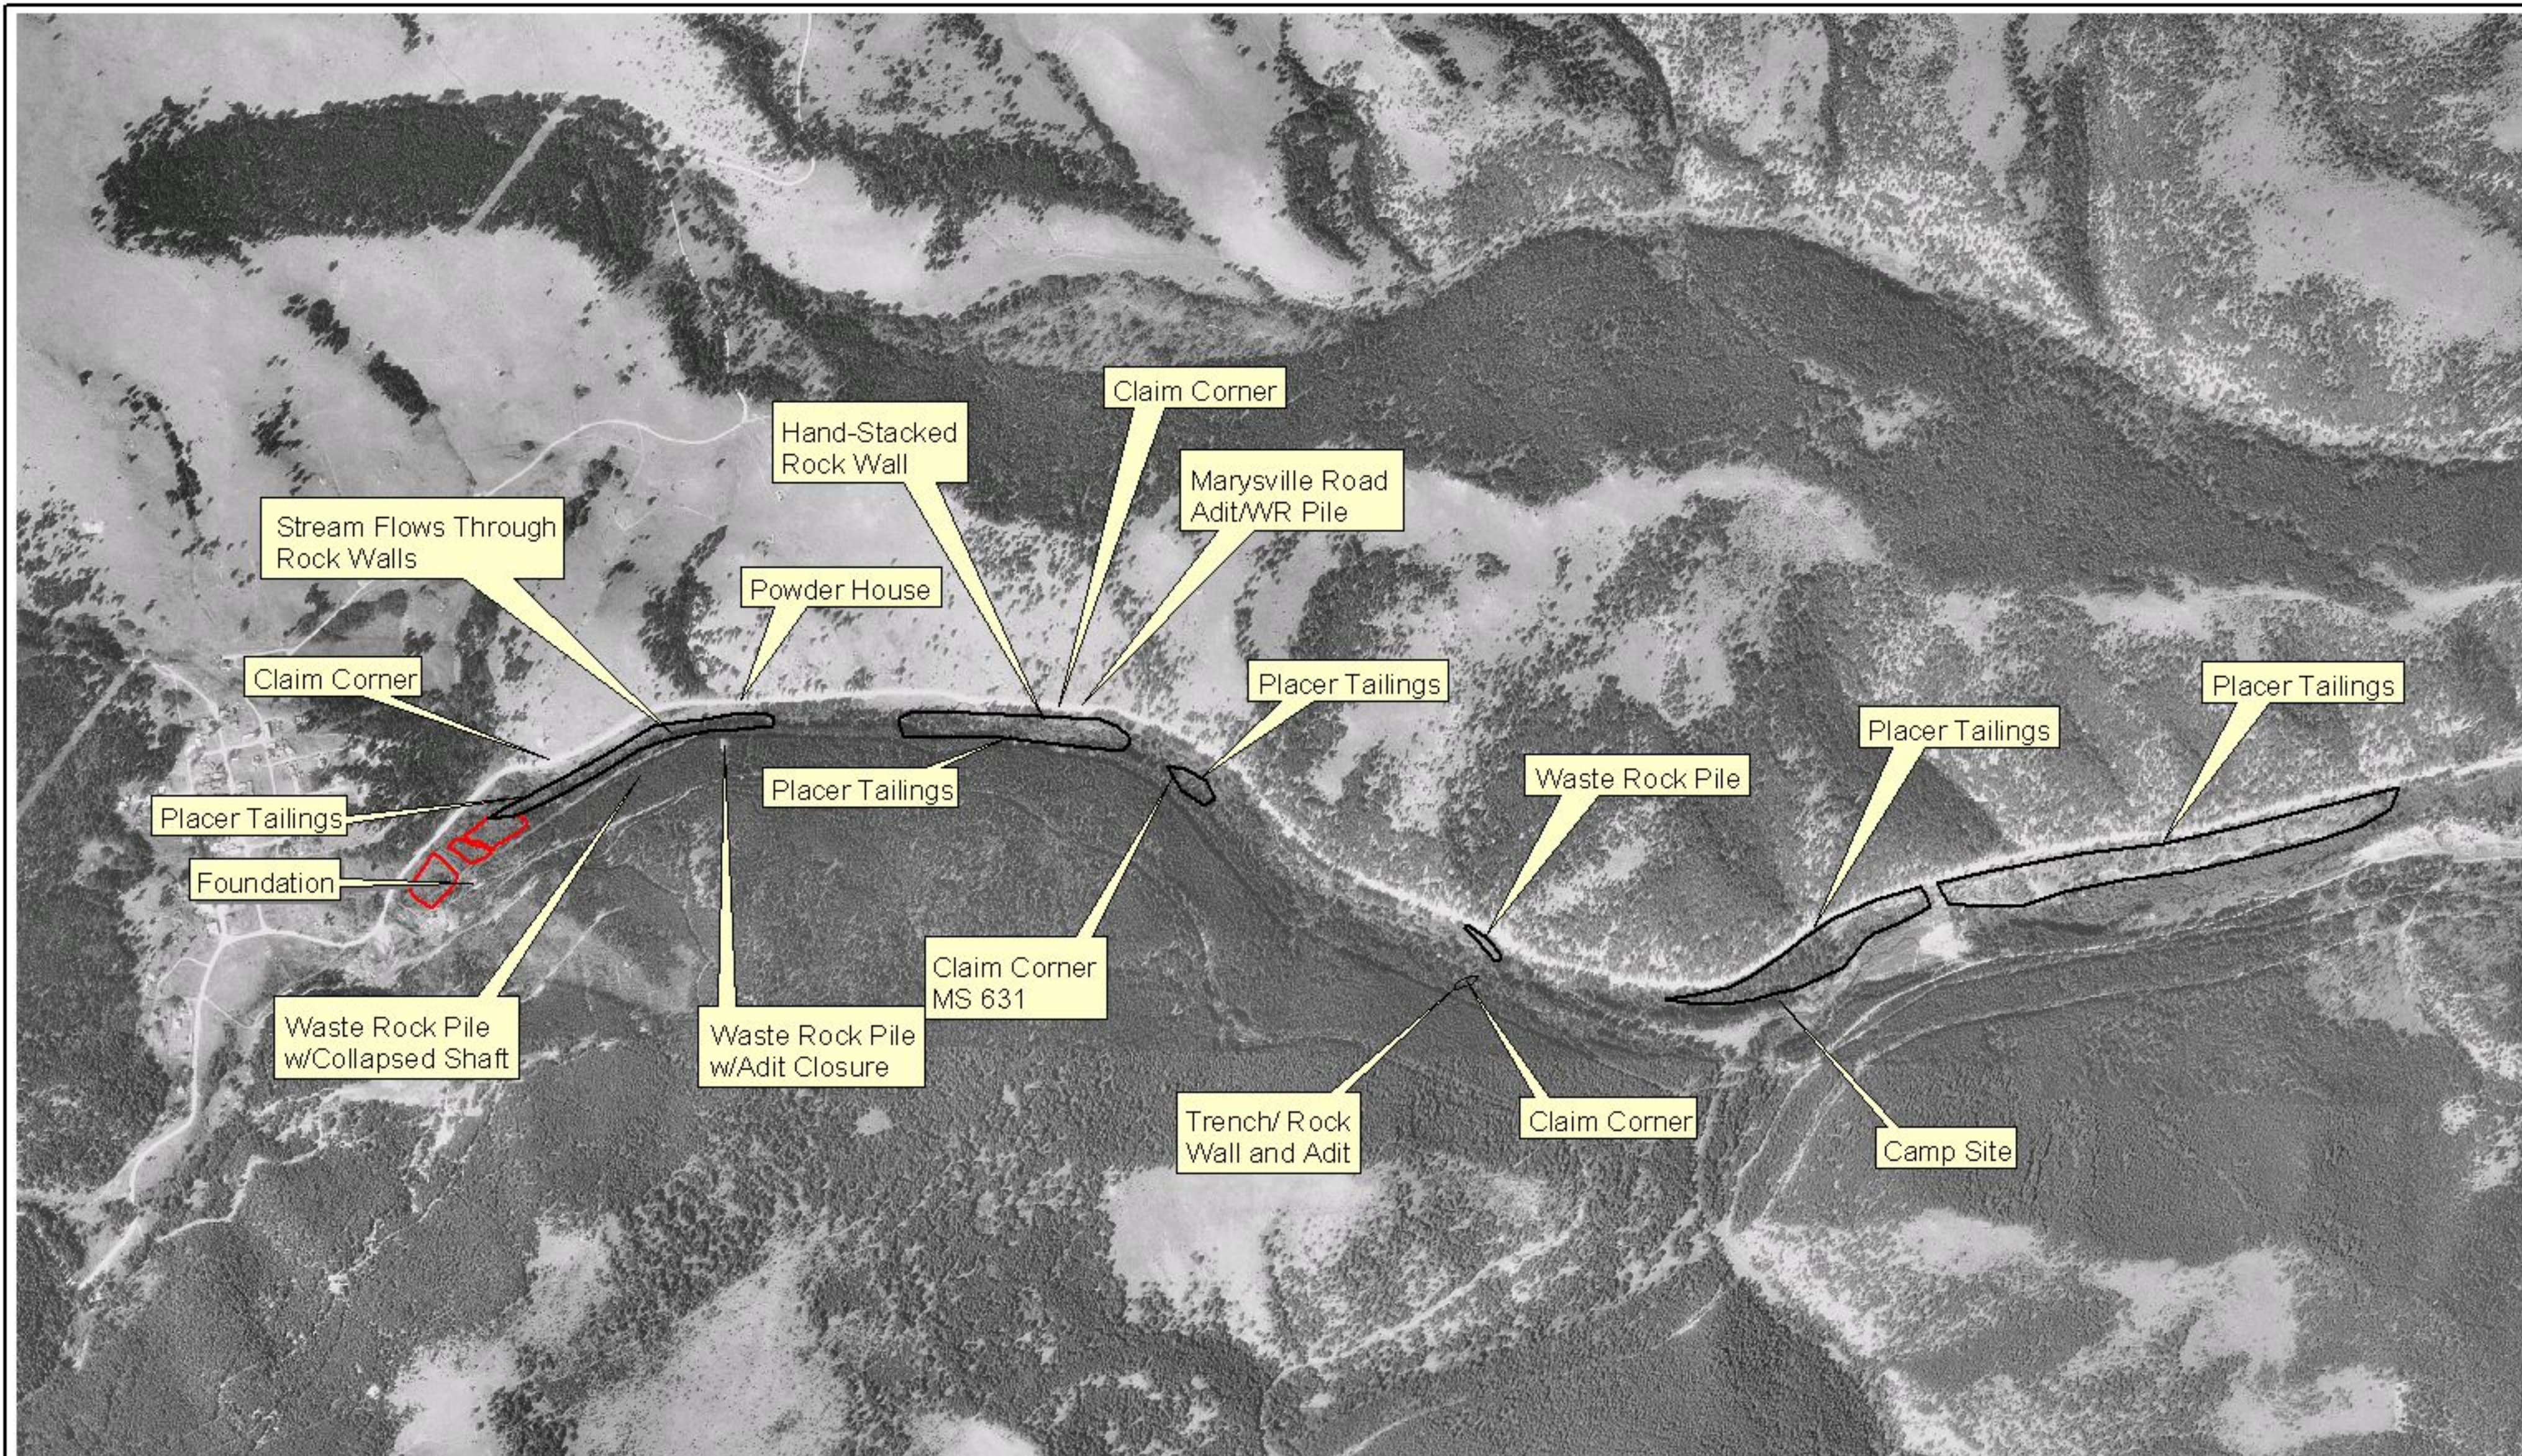
- several old dams on Silver Creek that are probably related to dredge operation (Figures 1-6 and 1-7);
- a possible mill building on the Gehring property (Figure 6-10), and
